# Scientific Investigation/ Survey at Settlement Plot No. 9130, District Varanasi

(Report submitted to the Hon'ble District Court, Varanasi)

Archaeological Survey of India  
2023

Volume 1

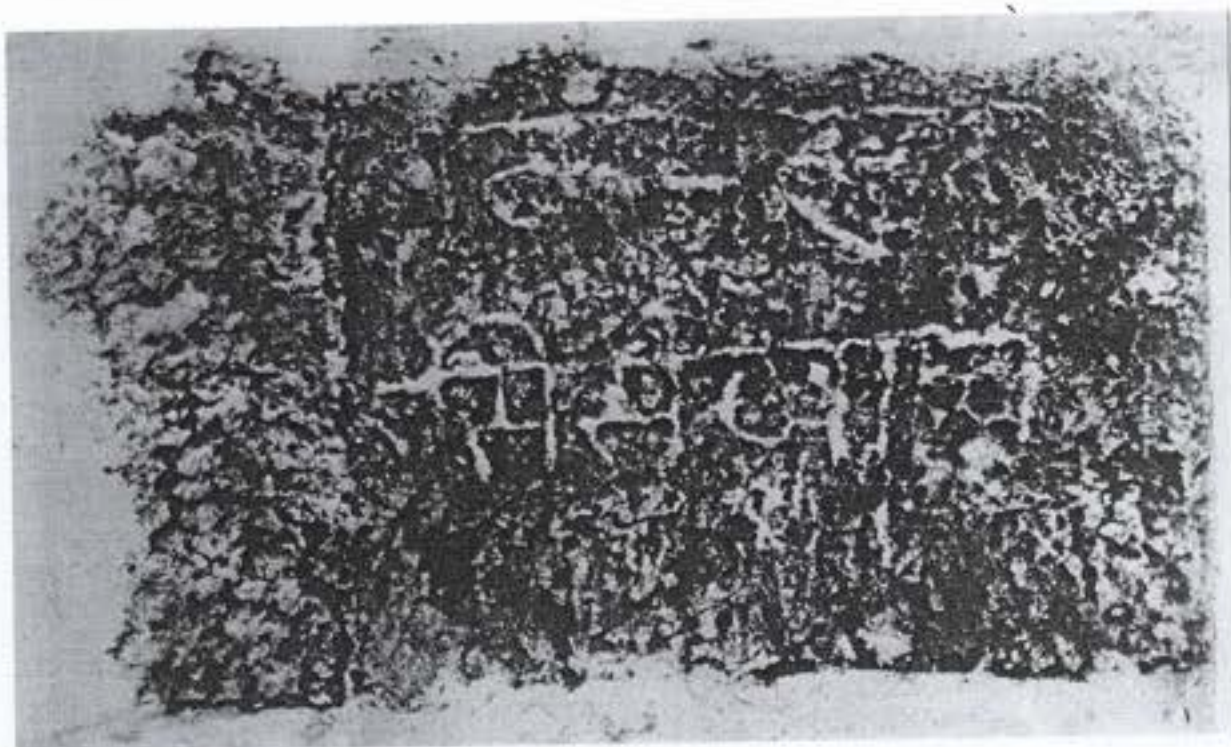
Inscription No. 02

Worn-out. Mentions the name of a person Āryāvātī. Other details are not clear. Palaeographically datable to 17th century CE.

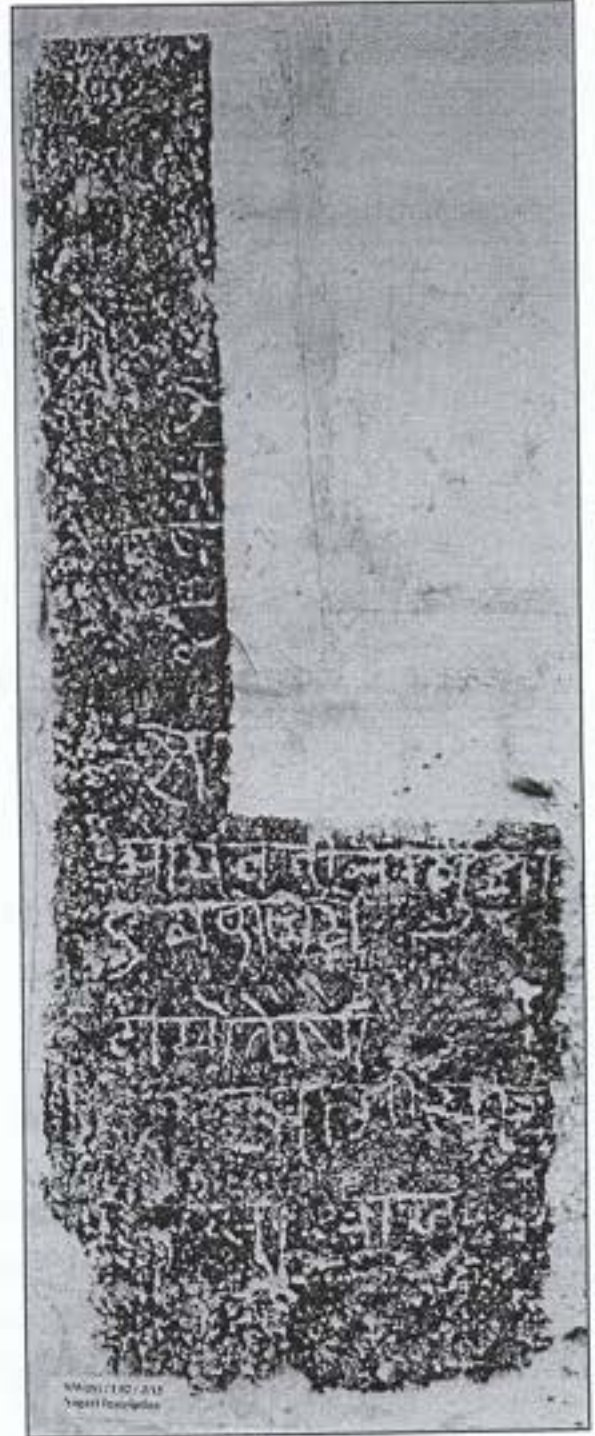
| Inscription No. | 03 |

| Gist | <p>Damaged and worn-out.</p> <p>Purport not clear.</p> <p>Palaeographically</p> <p>datable to 17th century CE.</p> |

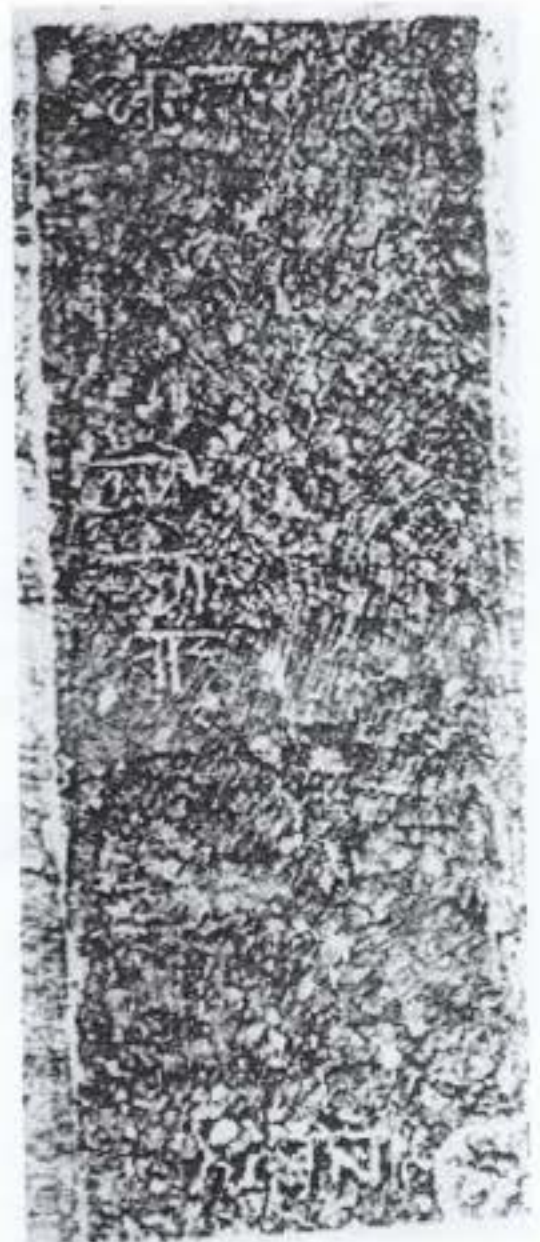
Inscription No. 04  
Date / Period 17th Century CE  
Location W(N) / I 04 / I/19  
Measurement of Stone slab 152 x 16 cm  
Language Sanskrit  
Script Nagari  
Text  
1. [मं]हामुक्तिमंड[पे]  
2. न्नोमै(नौमि) जाने-

Gist Worn-out. Records the obeisance made by an individual (name not mentioned) in Mahā-mukti maṇḍapa. Palaeographically datable to 17th century CE.

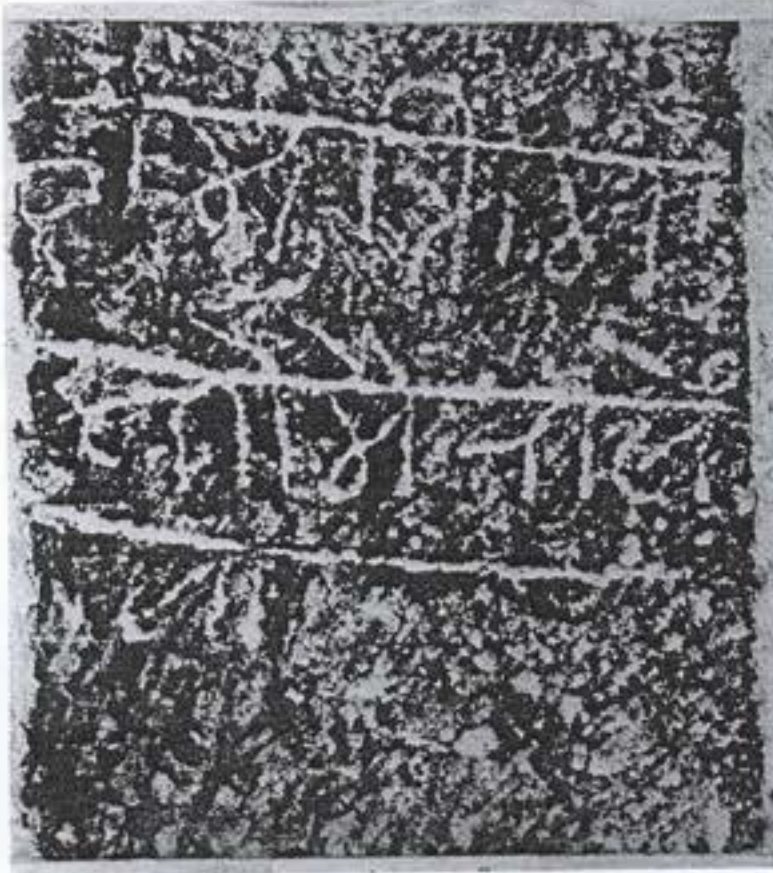
Inscription No. 05  
 Date / Period 17th Century CE  
 Location W(N) / I 05 / Q/20  
 Language Local dialect  
 Script Nagari  
 Text Top\*:  
 1. . . .  
 2. . म देवो

Gist Worn-out. Mentions names of two individuals i.e., Śumbhājī and Sōnājī. Other details are not clear. Palaeographically datable to 17th century CE.

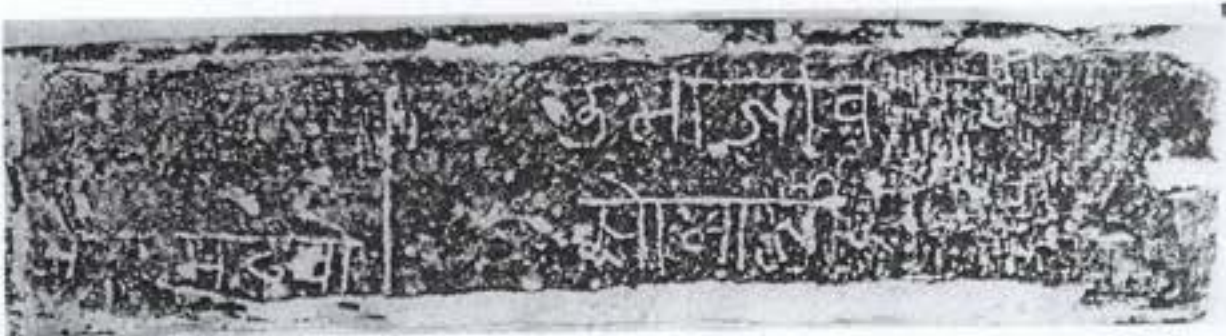
Inscription No. 06  
 Date / Period 17th Century CE  
 Location W(N) / I 06 / P/20  
 Language Telugu  
 Script Telugu

Gist  
 Damaged and incomplete. It mentions some individuals namely Mallana-bhaṭṭu, son of Nārāyaṇa-bhaṭṭu. Palaeographically datable to 17th century CE.

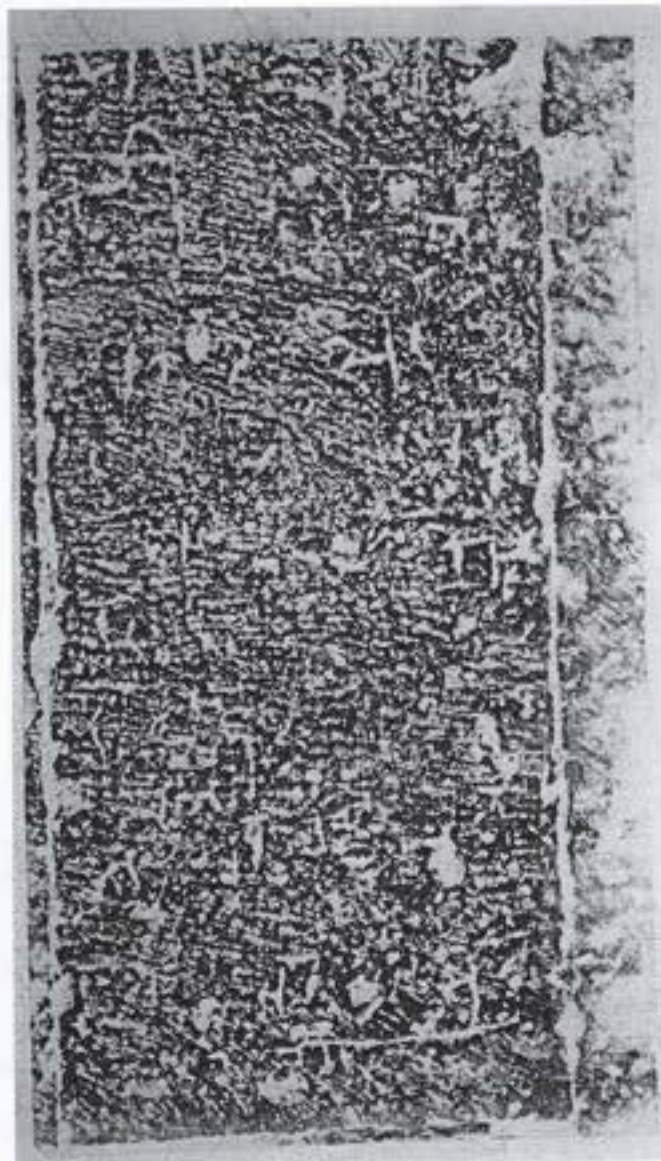
Inscription No. 08  
Date / Period 17th Century CE  
Location W(N) / I 08 / J/20  
Language Sanskrit  
Script Nagari

Gist Worn-out. Records the obeisance to Janārdhana (i.e., Vishṇu) made by an individual Jivāntadēva in Mahā-mukṭi maṇḍapa. Palaeographically datable to 17th century CE.

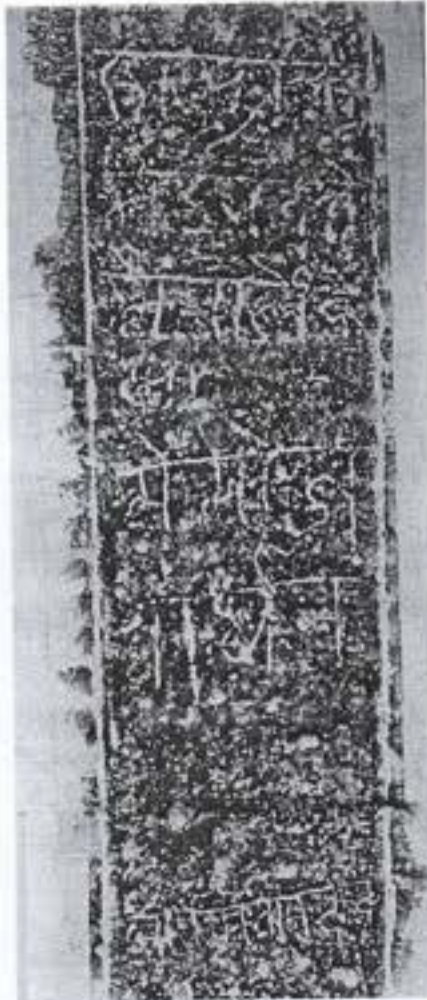
Inscription No. 09  
 Date / Period 17th Century CE  
 Location SW(S)/I 09-A / K/22  
 Language Tamil  
 Script Grantha  
 Text 1. नारायण[ण]  
 2. रामण स-

Gist Worn-out. Seems to refer some charity instituted by Nārayāṇa Rāmaṇ. Palaeographically datable to about 16th-17th century CE.

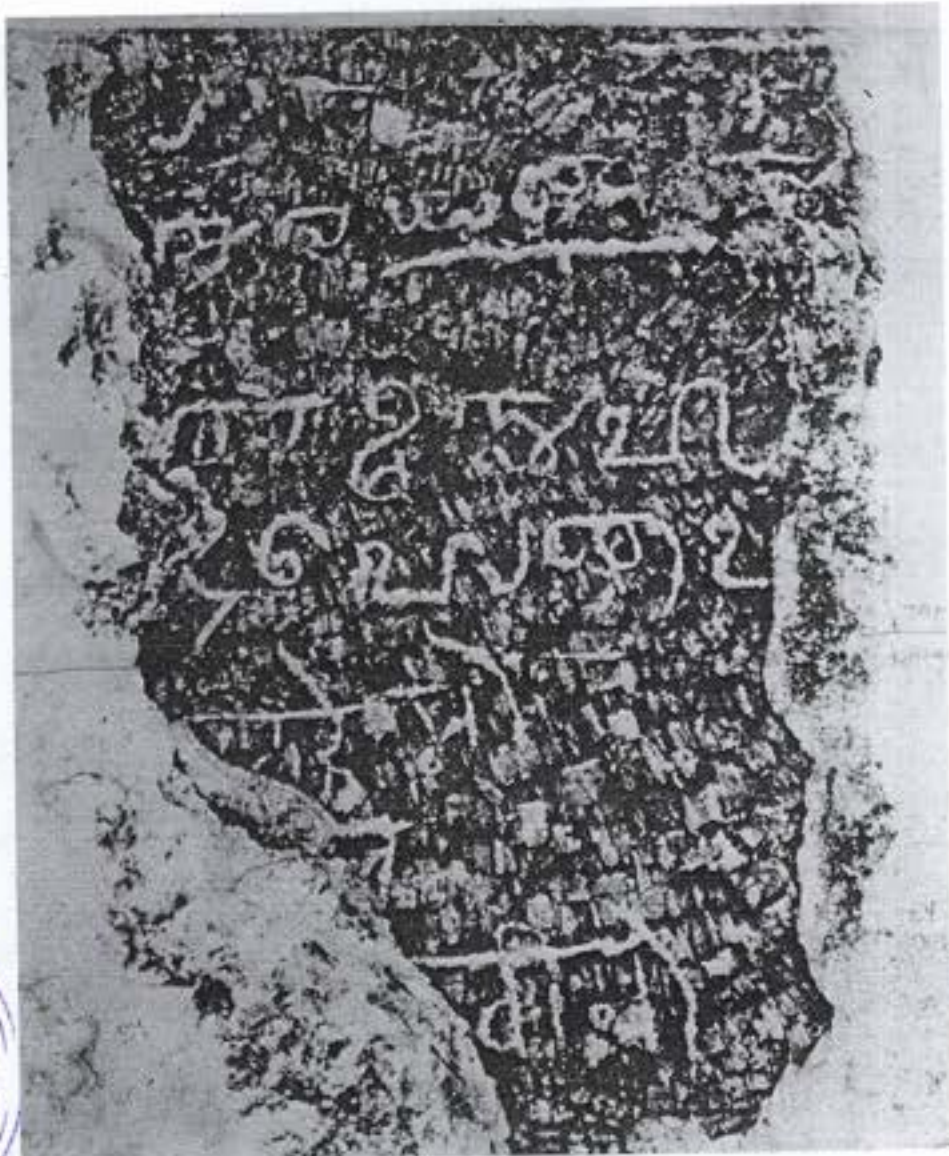
| Inscription No. | 10 |

| Gist | Damaged and worn-out. Mentions the name of a person hēmōja. Other details are not clear. Palaeographically datable to about 17th century CE. |

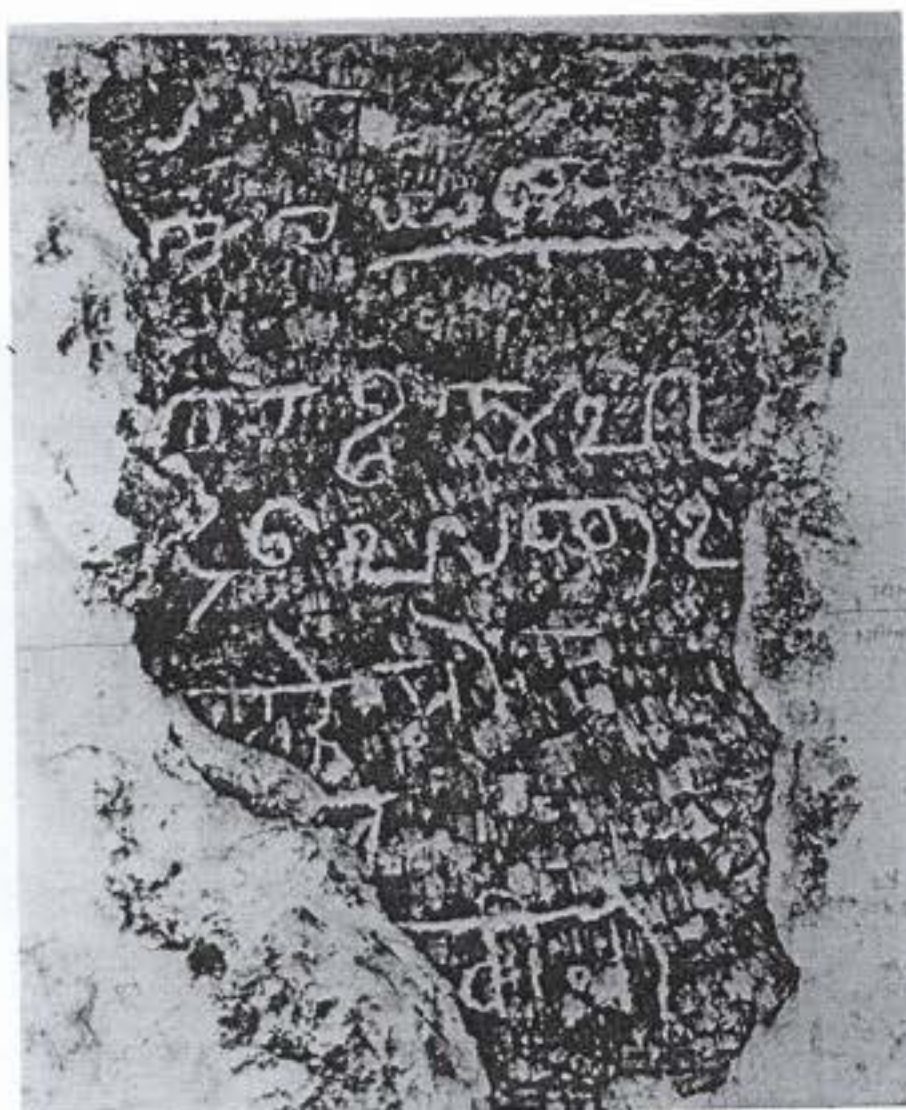
| Inscription No. | 11 |

| Gist | Damaged and worn-out. Purport not clear. Palaeographically datable to 17th century CE. |

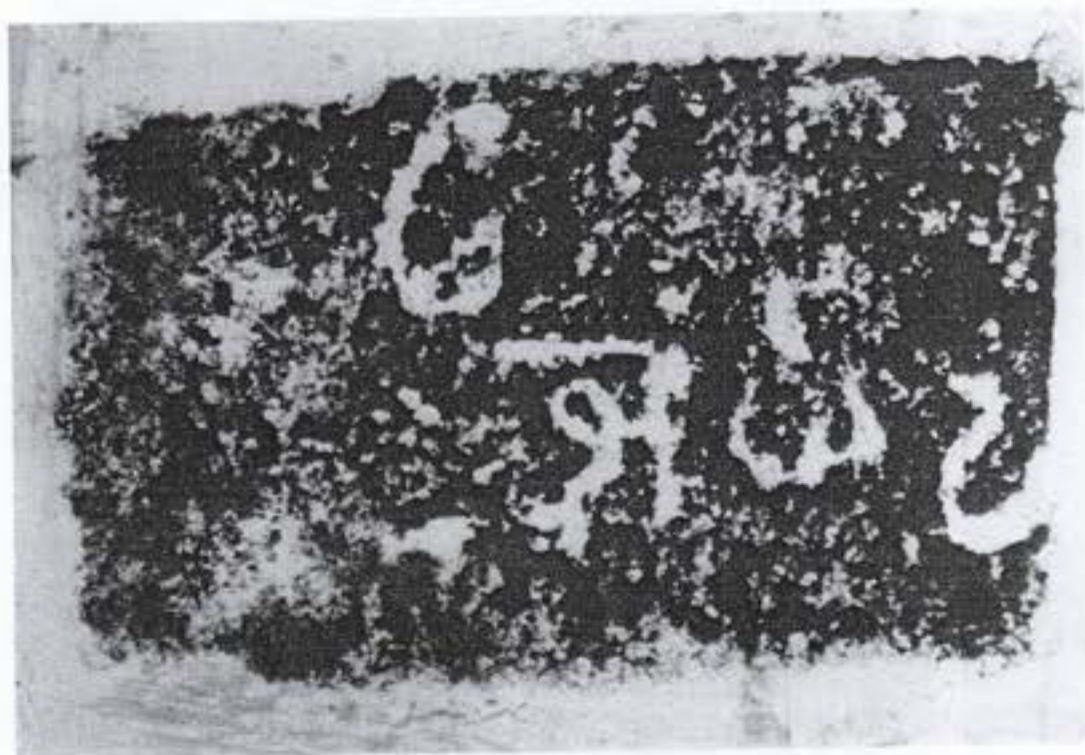
| Inscription No. | 12 |

| Gist | Worn-out. Purport not clear. Palaeographically datable to 17th century CE. |

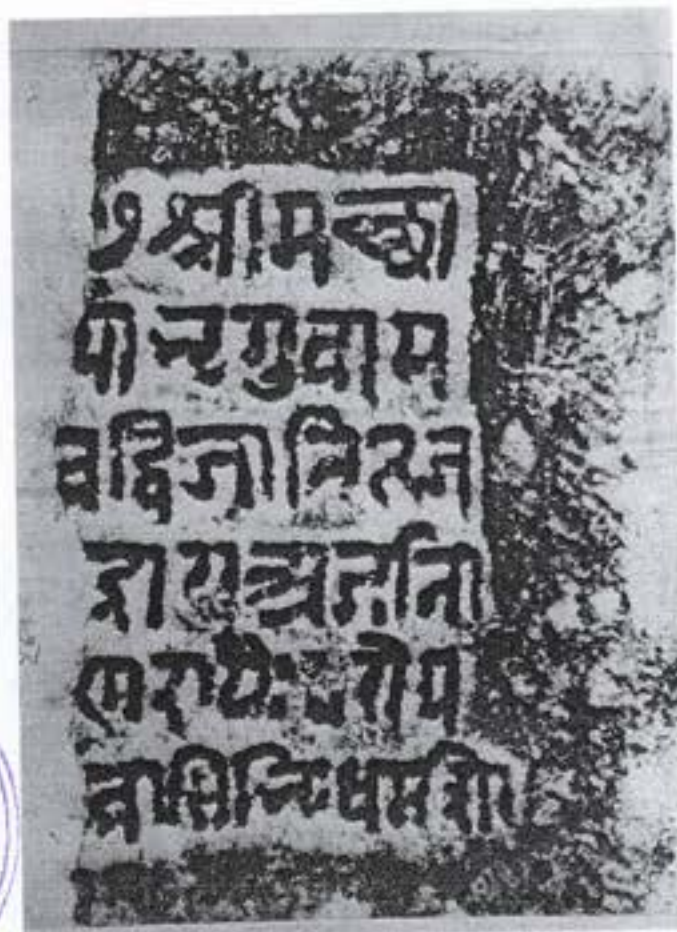
Inscription No. 14

Gist Worn-out. Purport not clear.  
Palaeographically datable to  
17th century CE.

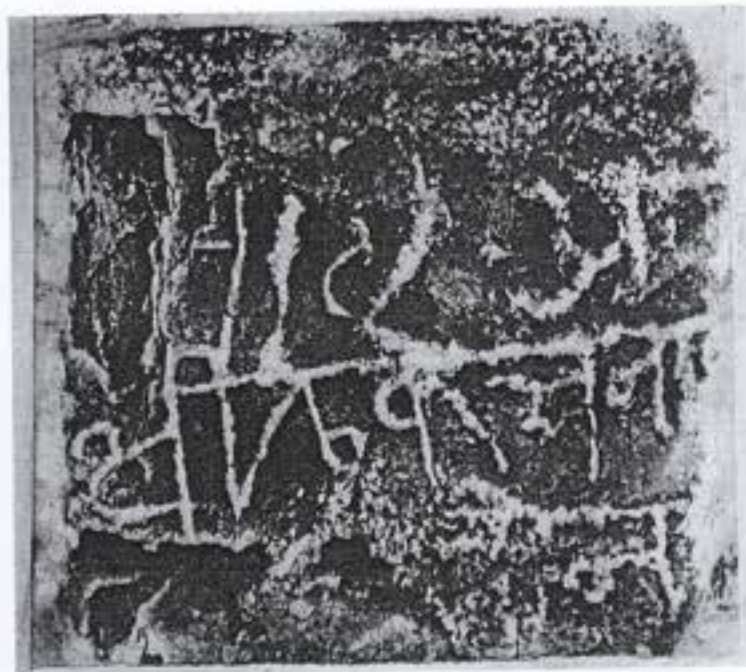
Inscription No. 16

Gist Incomplete. Seems to mention Rudrā (i.e. Śiva) in line 1 and name of the month Śrāvaṇā in line 2. It is written in Sanskrit language and Nagari characters. Palaeographically datable to 17th century CE.

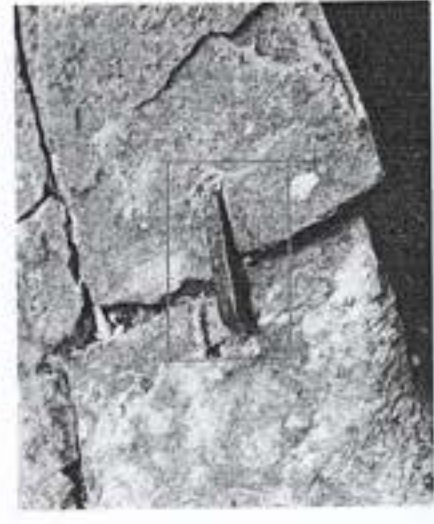
SI Location of iron/  
No. dowel/ clamp and id  
7. South side, plinth  
clamp 4 from west  
18082023-40

Average iron content, major and minor elements composition are almost similar in western wall and existing structure. Average difference of major elements iron and silica is 1.6. Average iron content is below 90% in south side clamps (average difference is 3.90 - 5.50) and also aluminum detected uniformly in south side samples but not in western wall and existing structure. Presence of lead and zinc in traces is detected in south side but not in western wall and existing structure (Table No. T-3; Graph No. G-2).

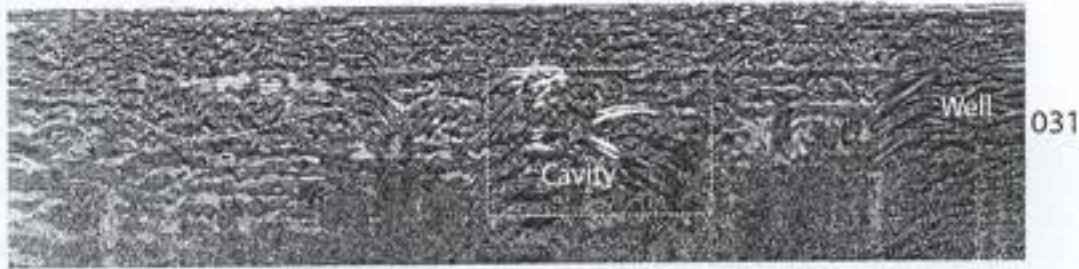
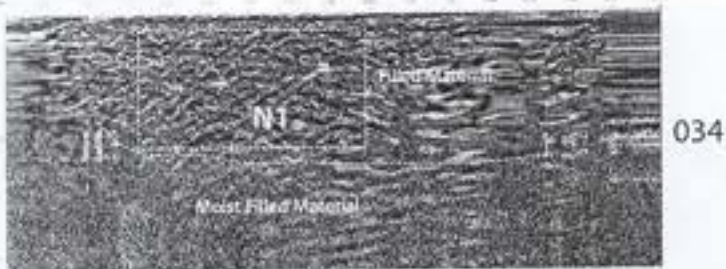
Profile no. 031 to 034, taken on the eastern and northern outside wall, and N1 cellar (Fig. 19). The 'well' signature is also observed in the profiles 031 and 032. The cavity of cellar N1 is observed in the profile no 033 and 034 (Fig. 20).

Figure 20: GPR profiles of the outer eastern walls over the functional well, and cellar N1.

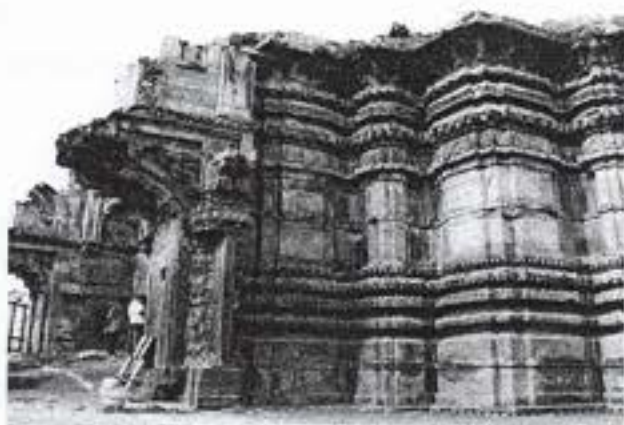
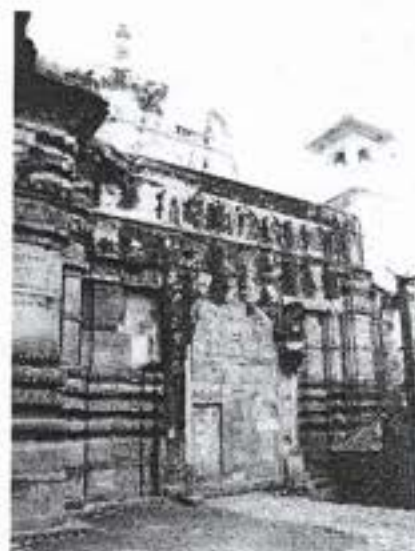
General views of Section 'A' of western wall

1. Multi coloured sandstones are used as construction material like yellowish, light pink, dark tan, buff and light reddish.
2. Entire portion is constructed by plain and carved sandstone blocks fixed using lime aggregate mortar. Wall surface of this area is partially lime coated.

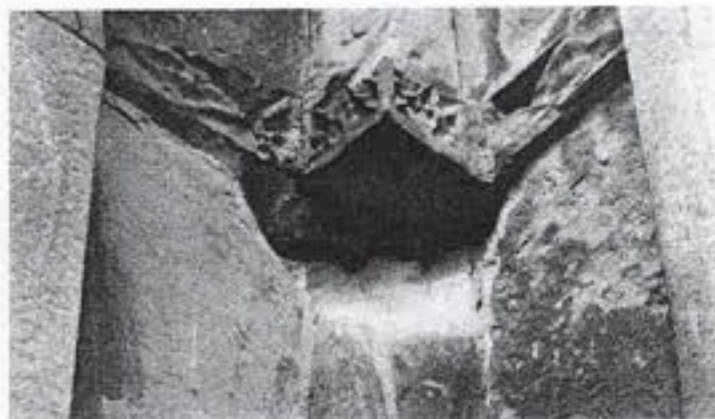
Bursting

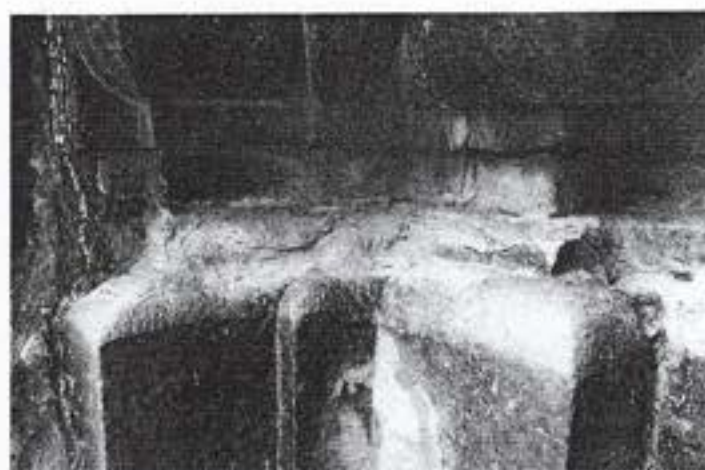
Discoloration

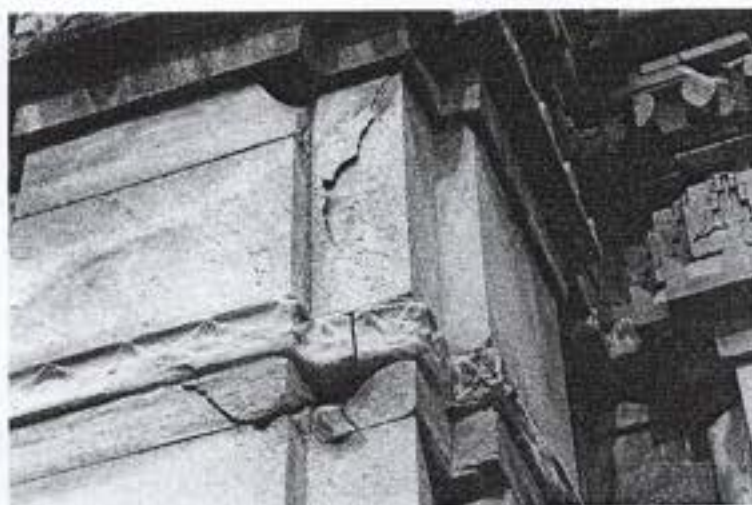
Flaking and Fracture

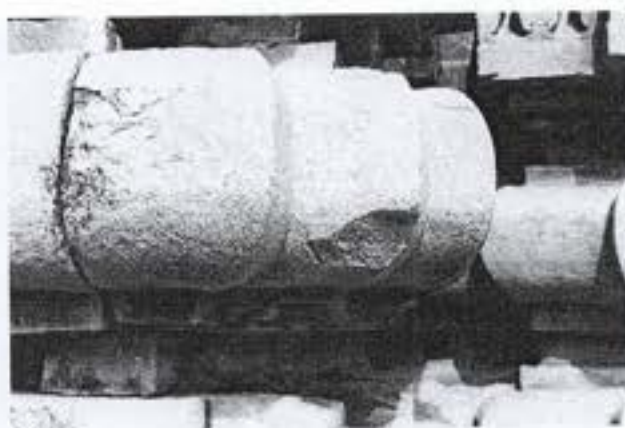
Surface erosion

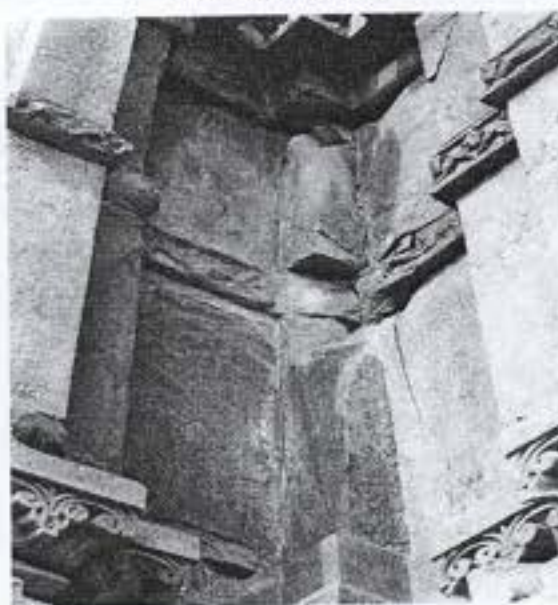
Peeling

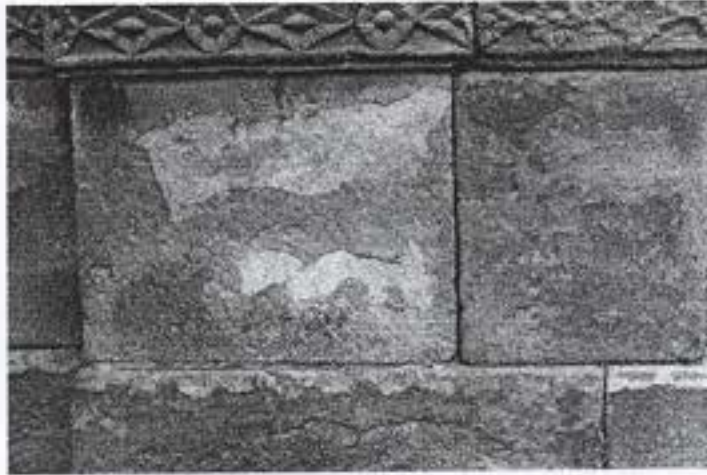
Scaling

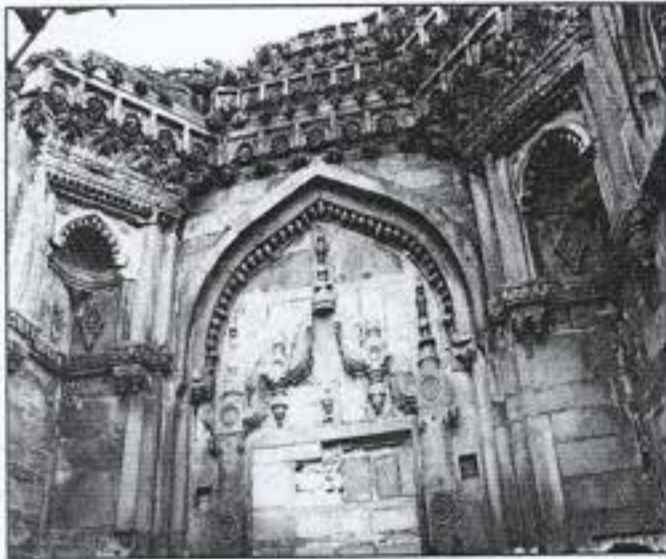
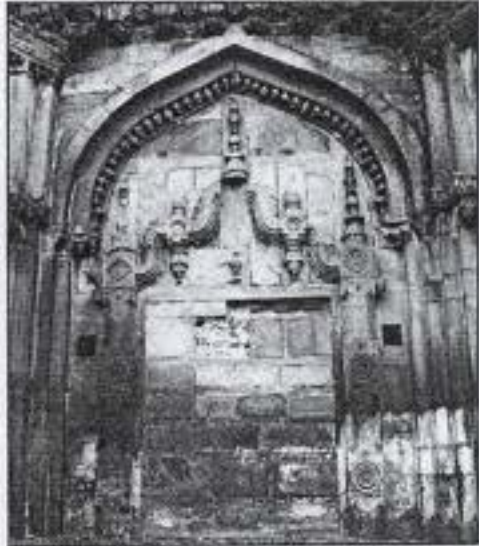
Biological colonization and discolouration

Lime wash

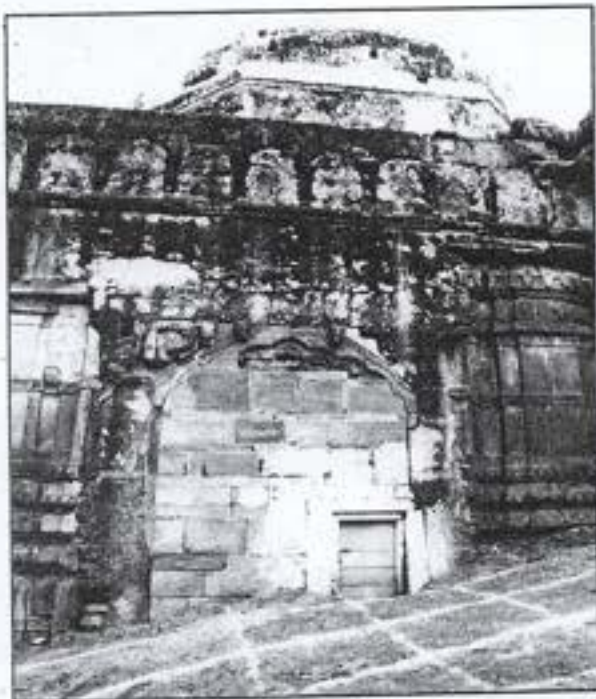
Formation of biofilm and lime wash

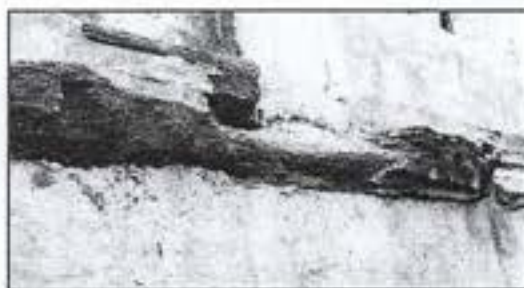
Delamination

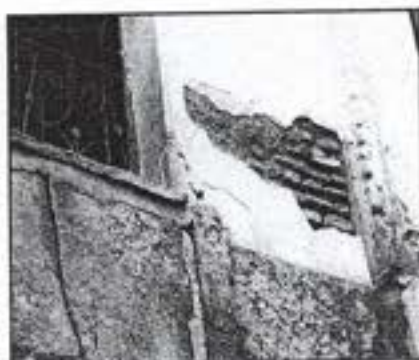
Exposure of ancient bricks due to loss of binding materials

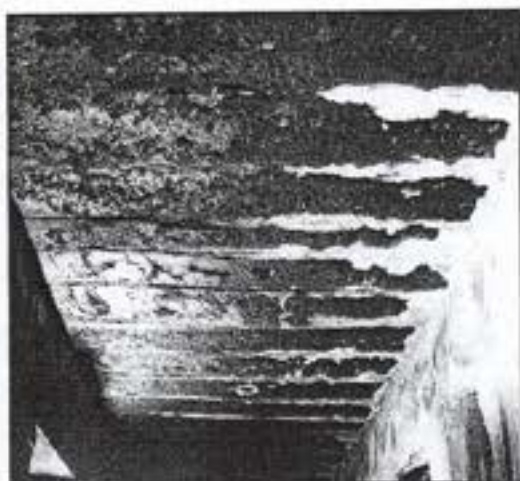
Salt incrustation and deposition of soot on ceiling

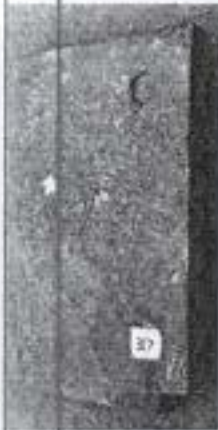
| Sl. No. | Acc. No. | Description | Material | Location | Measurement<br>Height (H), Width (W),<br>Diameter (Dia.) / Thickness (Th.),<br>(in cm.) | Photograph |
|---|---|---|---|---|---|---|
| 173 | 317 | Stone slab depicting trefoil<br>motif | Stone | Cellar (N2) | 69 x 42 x 9 | |

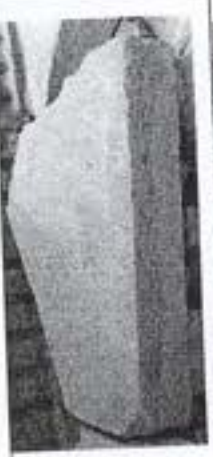
| Sl. No. | Acc. No. | Description | Material | Location | Measurement<br>Height (H), Width (W),<br>Diameter (Dia.) / Thickness (Th.),<br>(in cm.) | Photograph |
|---|---|---|---|---|---|---|
| 174 | 318 | Broken stone block contains bracket drawing | Stone | Northwest side | 112 x 83.5 x 21 | |

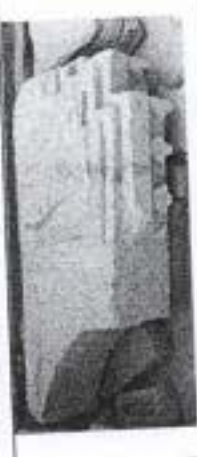
| Sl. No. | Acc. No. | Description | Material | Location | Measurement<br>Height (H), Width (W),<br>Diameter (Dia.) / Thickness (Th.),<br>(in cm.) | Photograph |
|---|---|---|---|---|---|---|
| 175 | 319 | Architectural fragment having trefoil motif | Stone | Northwest side | 119 x 57 x 30 | |

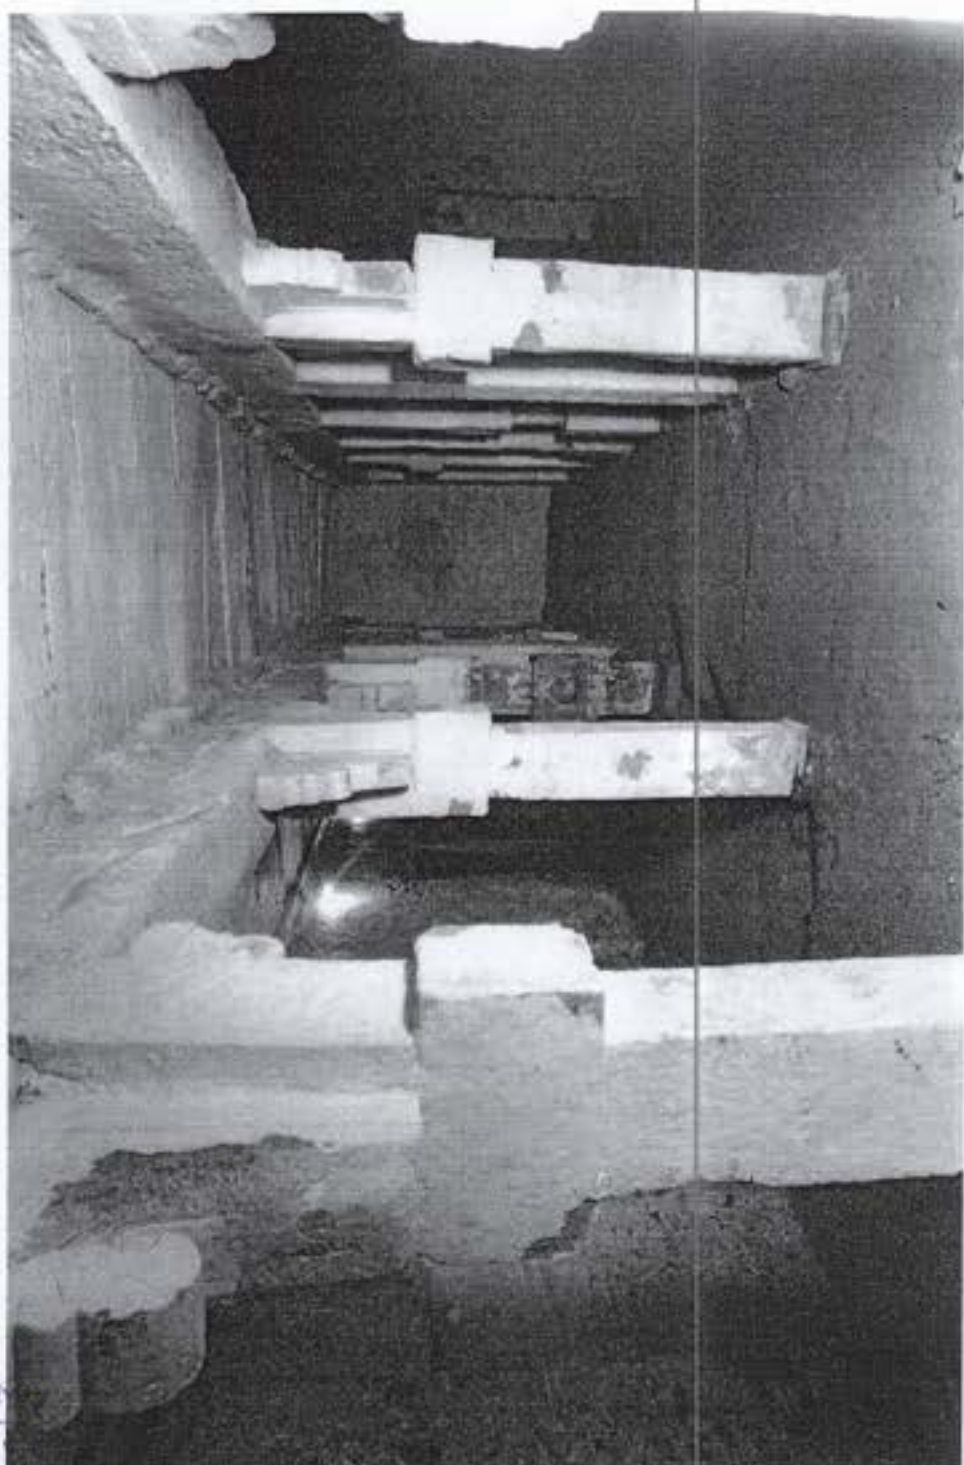
Cellar N2: Nave, after cleaning

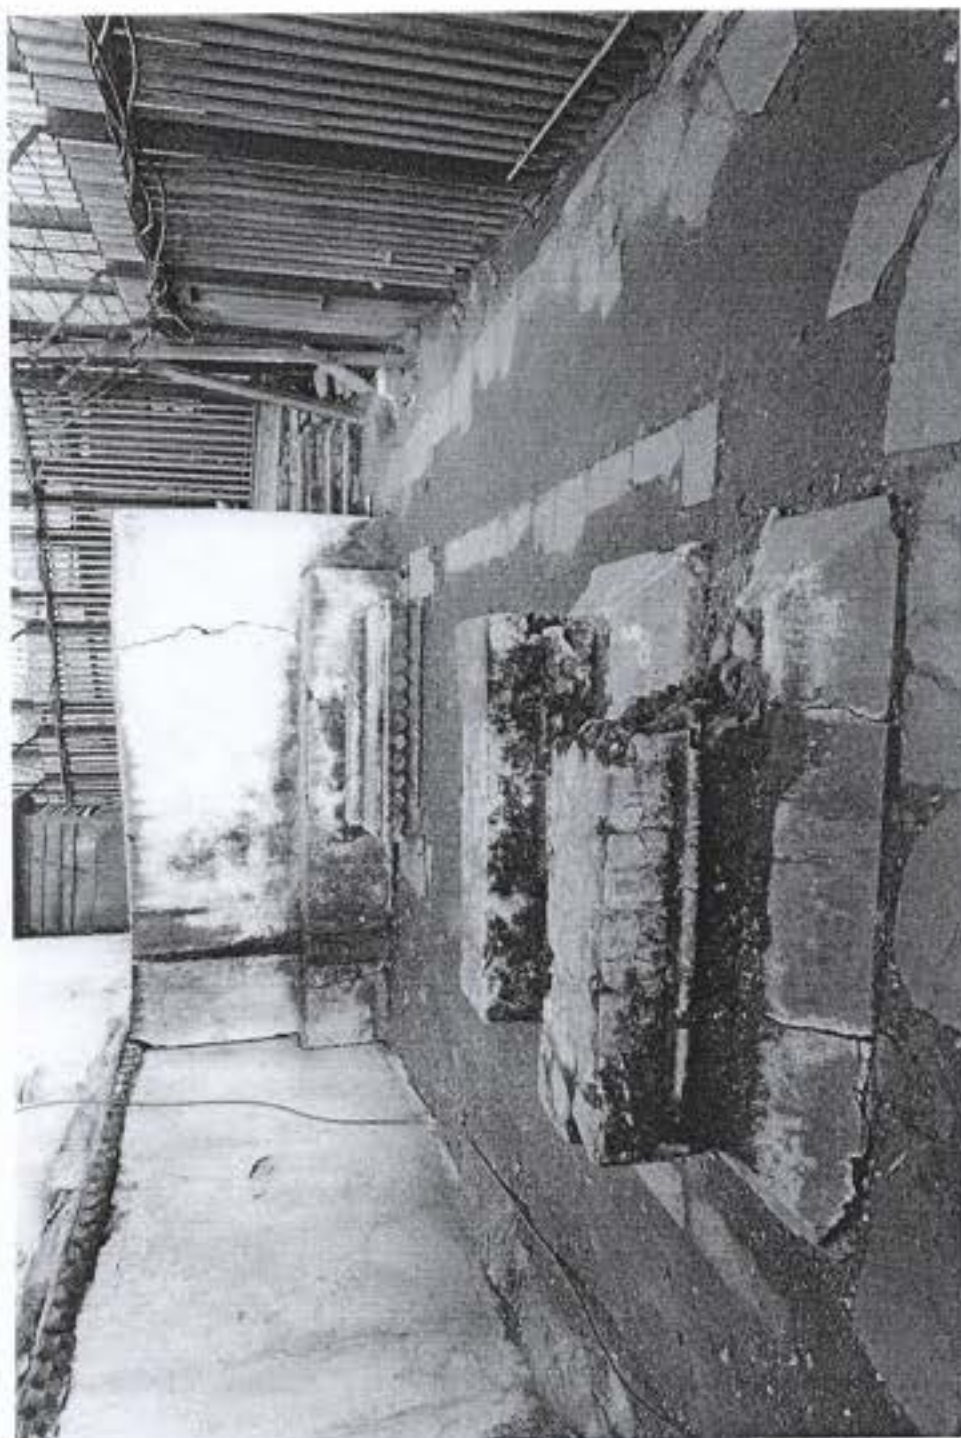
North Side: Area near graves, after cleaning

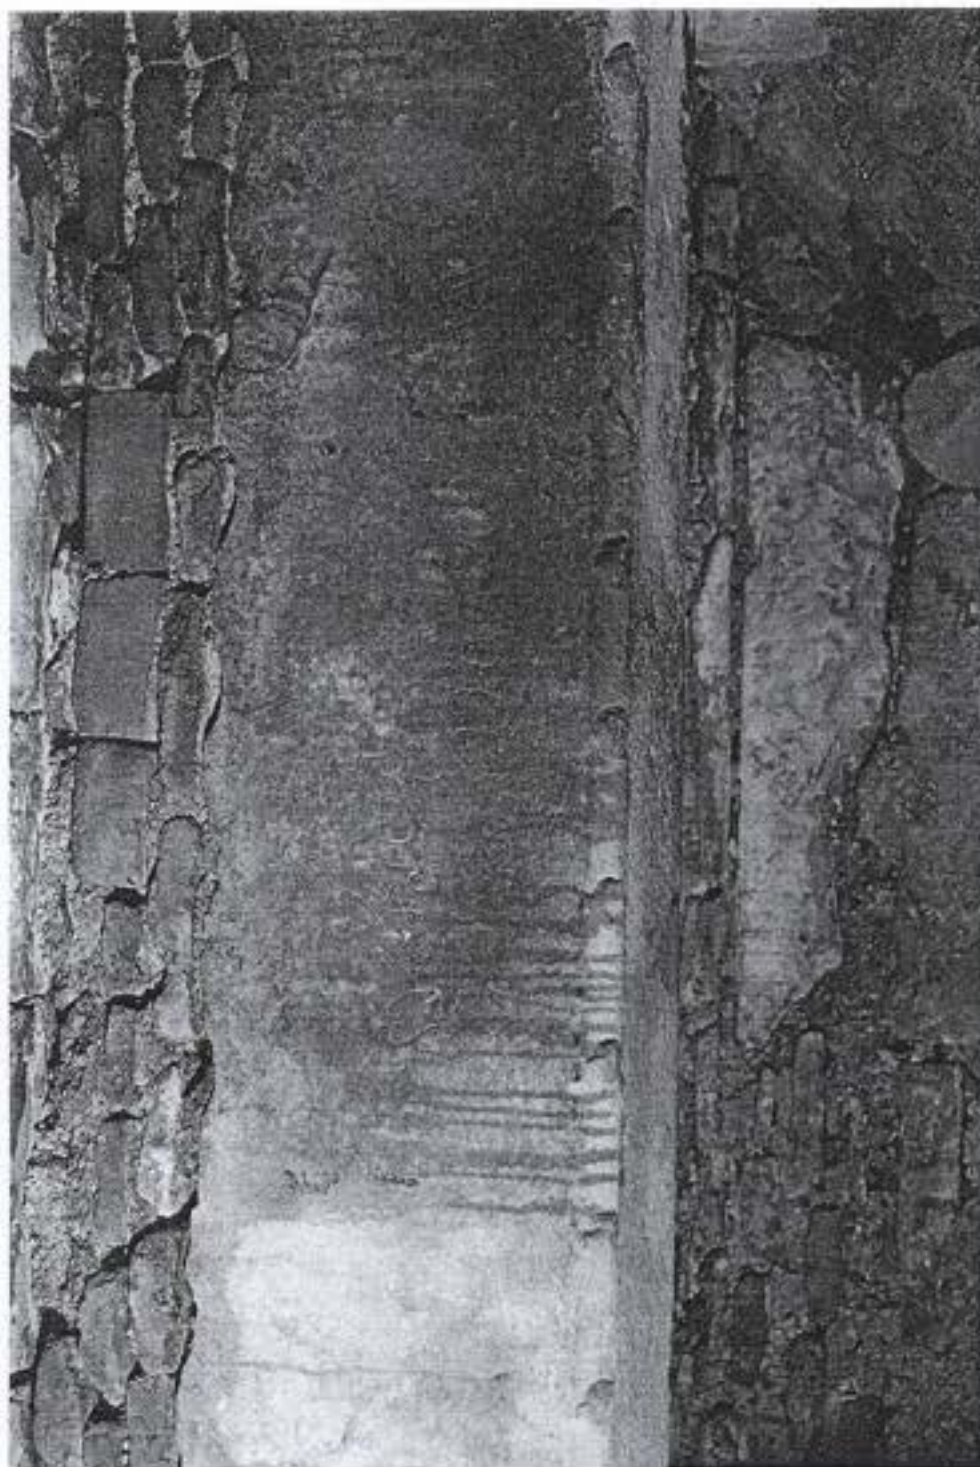
Shop 3: Inscriptions on lintel

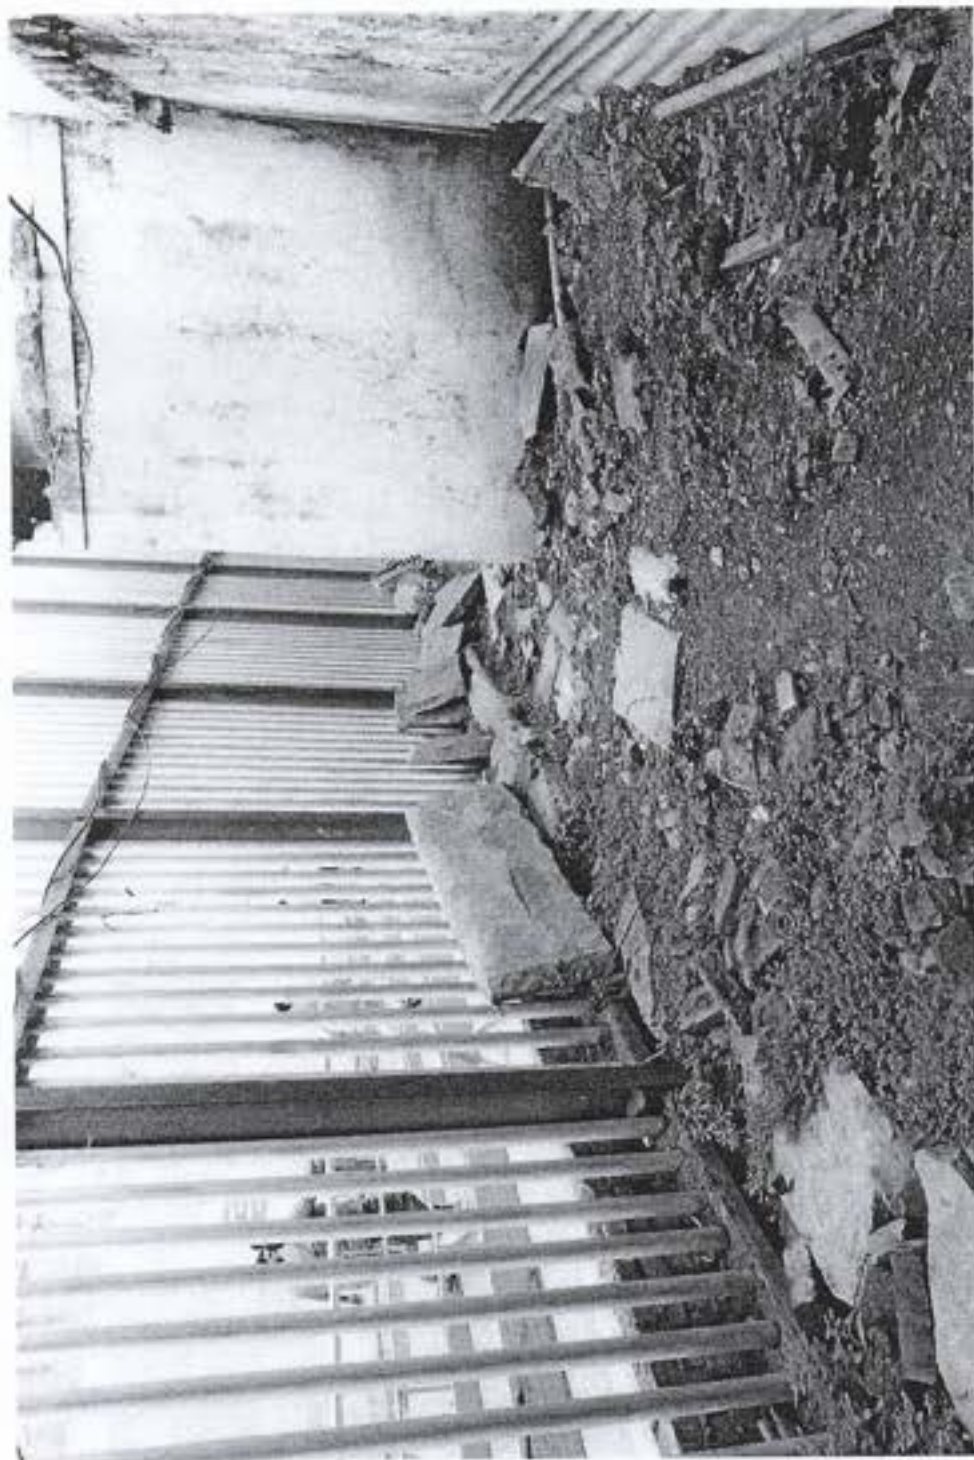
East Side: Before cleaning

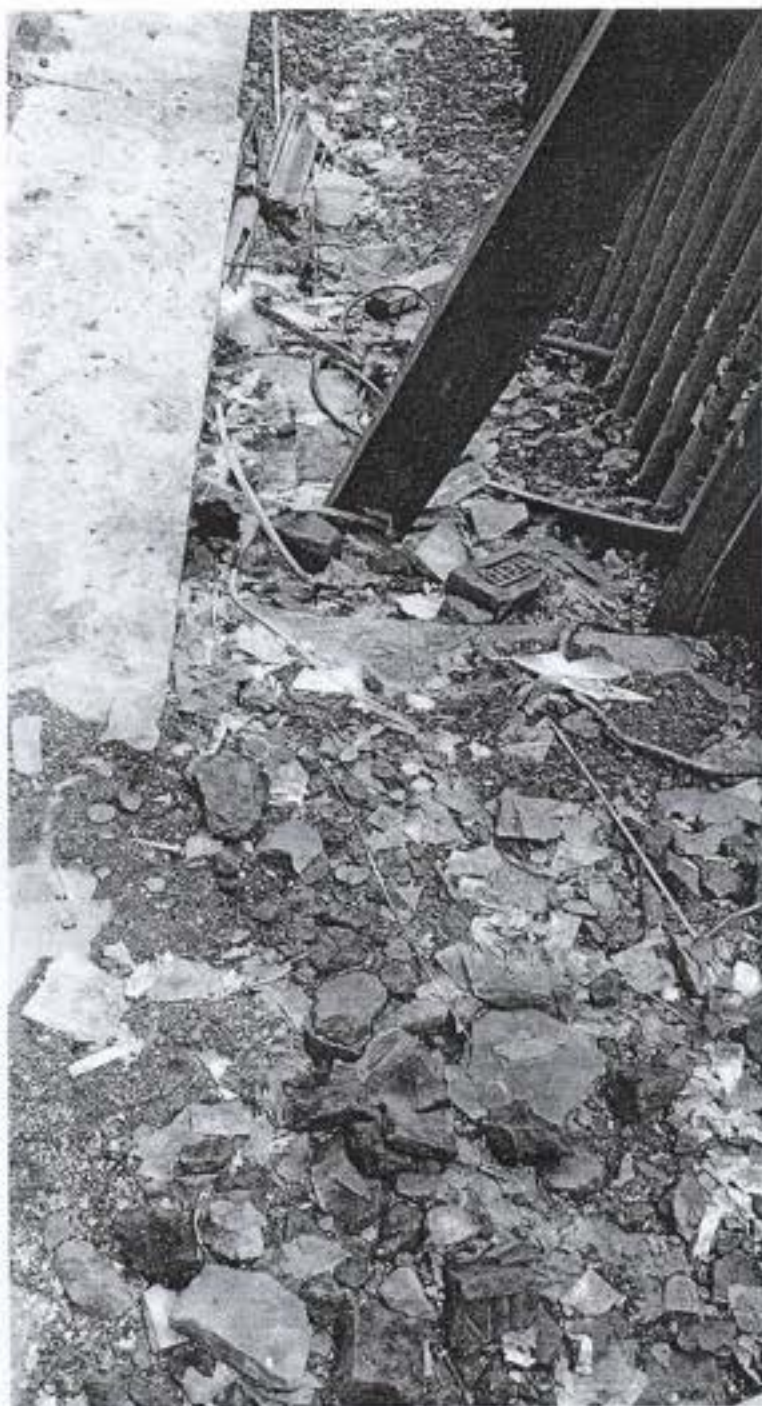
South Side: Garbage deposit
